Blue Mountain Ranger District Aquatic Restoration Efforts

Wednesday June 20, 2018 BMFP Field Trip

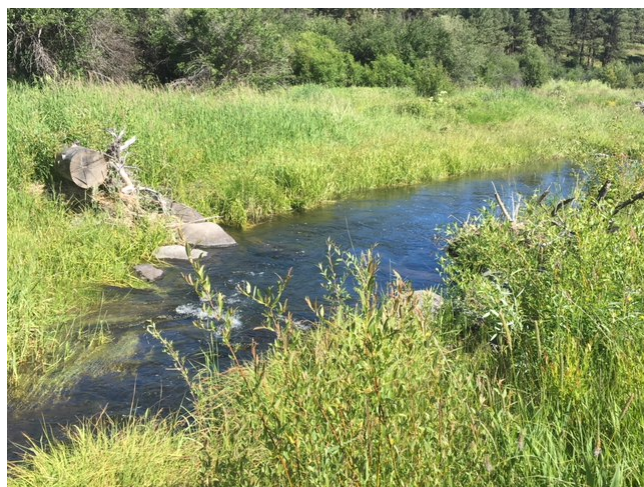
Top left-hand corner shows portion of log weir after main section was removed. Camp Creek has since deepened and narrowed at this spot (classified as a Rosgen F stream channel type), which is good for fish, but can't connect to the surrounding flood plain.

Due to the lack of channel roughness, recovery of the stream channel width and associated vegetation recovery has been a slow process. Given the target or focus, the project was successful in addressing the problems log weirs unexpectedly created. Still, the water temperature remains too high for steelhead and the stream channel overwidened. Also, LIDAR shows numerous other stream channels adjacent to the site which, if connected, would facilitate floodplain connectivity more broadly and address other important aquatic issues in addition to fish habitat.

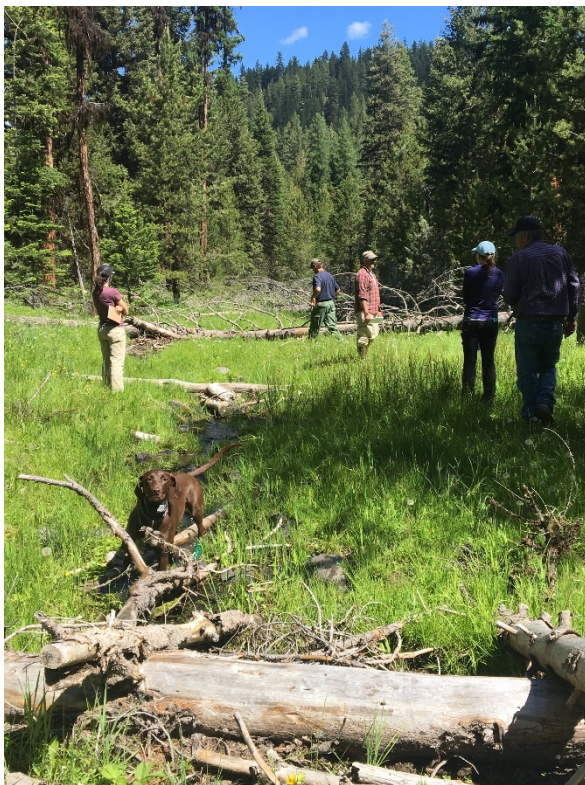
Upper reaches of Camp Creek looking downstream at trees and debris placed across the creek.

seeing fish. The felling method seems to be effective; chainsaws were used instead of heavy machinery which left little impact on the area. Felled trees were modified some (e.g. branches were cut). They are similar to BDAs in holding back or spreading water and increasing deposition; juvenile fish can work through them. BDAs were made with Grand Fir and Lodgepole.

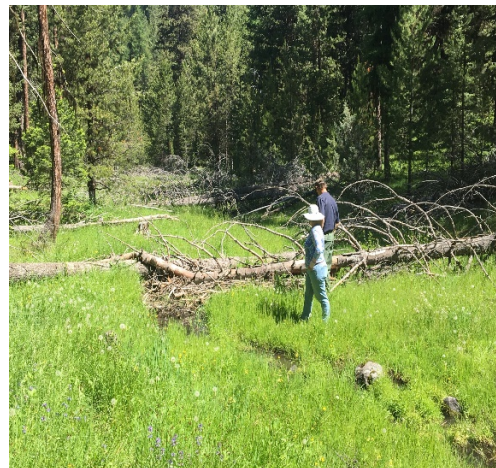
Another view looking downstream with trees cut to fall across the stream to spread high water and increase soil deposition.

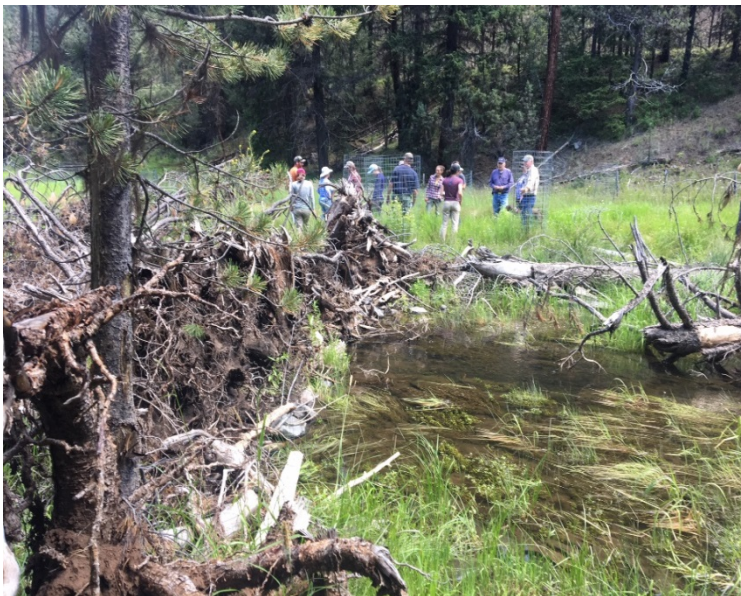
Looking east across Camp Creek above numerous root wads at caged willows. The root wads provide fish habitat, increase soil deposition, and with high flows spread water connecting the floodplain.

Summary: The goal of this project was to reconnect 12 miles of side channels. This was done using BDAs, wood jams, and vegetative replanting. This site has experienced significant changes already, with over 1 foot of water spreading across the floodplain in a normal water year. In the springtime water flows over the BDAs and through side-channels to inundate the entire floodplain.

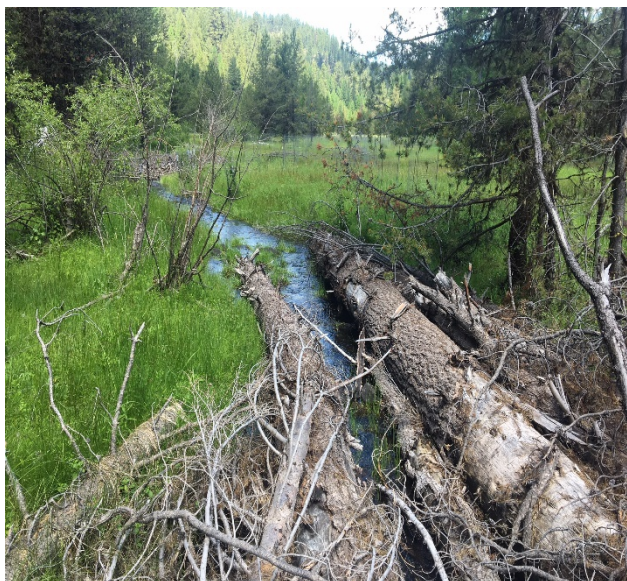
Looking downstream from the root wads in the above photo.

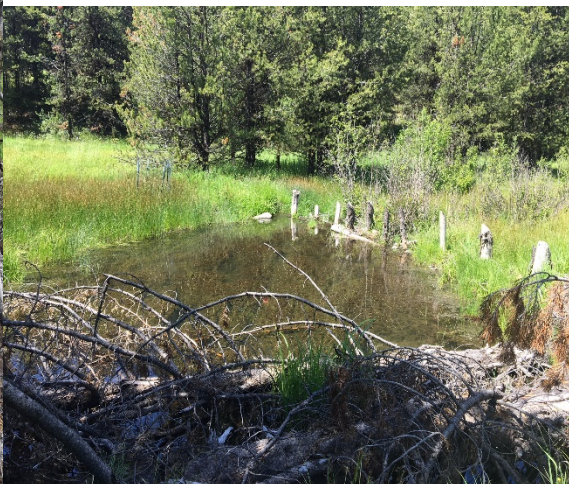
Looking downstream at an ABD. Small tree stems and limbs are woven among wood posts driven in the stream channel to function like beaver dams.

- Some talk six months ago about it: tried to use wood pieces to anchor BDA corners. Willows that were woven into the BDA have stuck and are self-maintaining.

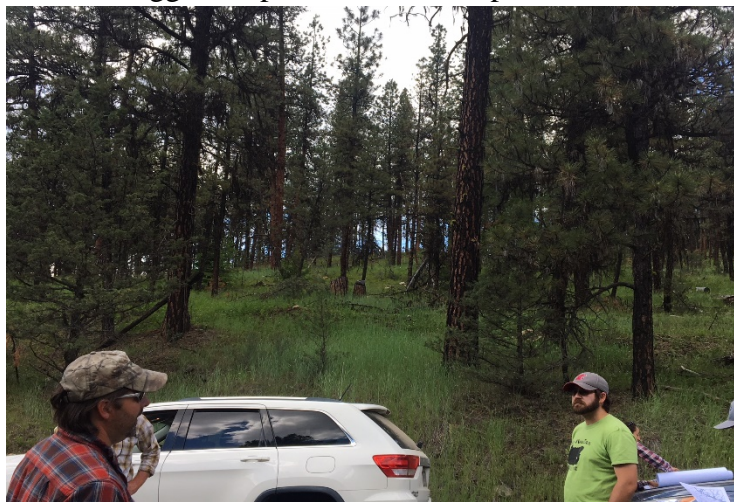
On East Fork of Beech Creek looking north toward a unit that was not economically viable to harvest but did need thinning. Trees for the stream restoration work along the creek were taken from this and other nearby units.

creek. Acres was a commercial unit that was dropped because it was not economically viable. It cost \$75k to harvest and remove the trees and \$70k for 6 weeks of work by two excavators to place them in the creek. The project has been effective in providing rearing habitat, connecting the floodplain, and withstanding a very high-water event. It nicely combines aquatic and veg restoration efforts and represents an integrated approach to aquatic restoration that achieves multiple objectives.

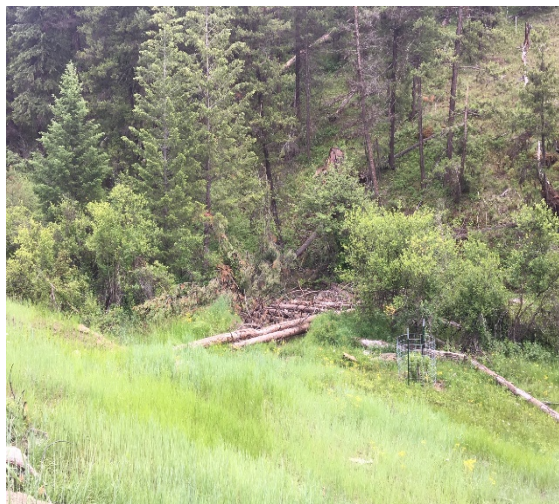
Looking at a “debris jam” created by excavators with trees taken from the adjacent unit. Caged plantings can also be seen in the photo.

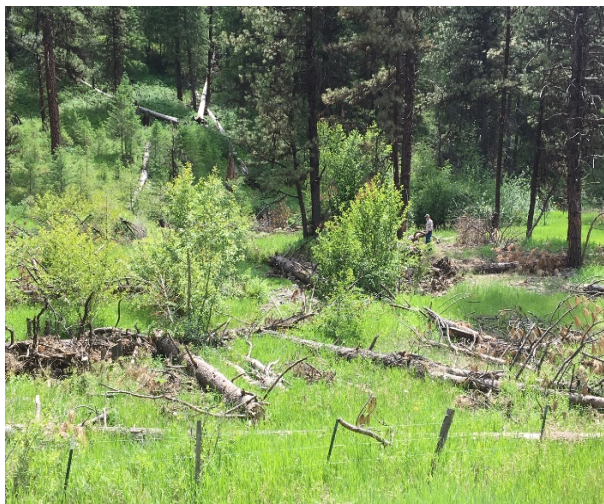
Looking further downstream at assorted wood placement to spread water and connect the floodplain.
